## There are no short cuts to safety!

### Dangerous currents.

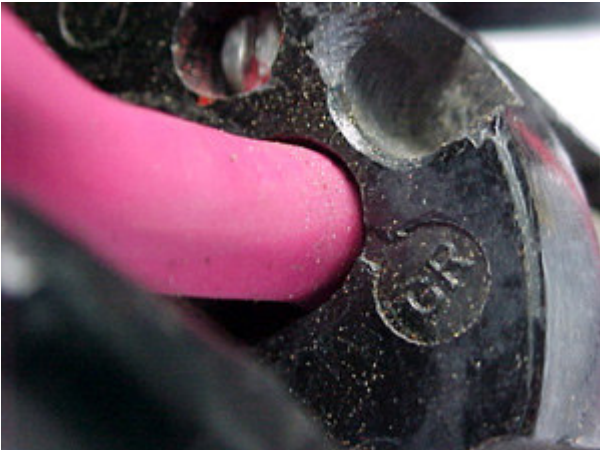
**The investigation revealed that the boat owner failed to connect the grounding (bonding) wire to the female plug, which ultimately led to an ineffective ground-fault return path.**

However, in making the conversion, he also altered the female plug connector at the boat. In doing so, he miswired the ground and hot wire, thus energizing the boat's aluminum hull, railing, and ladder. In addition, the wiring within the boat had been altered. Additional circuits had been added, and the incoming power had been changed from 125V (as designed) to 125/250V, which had exceeded the listed rating of the houseboat's female receptacle.

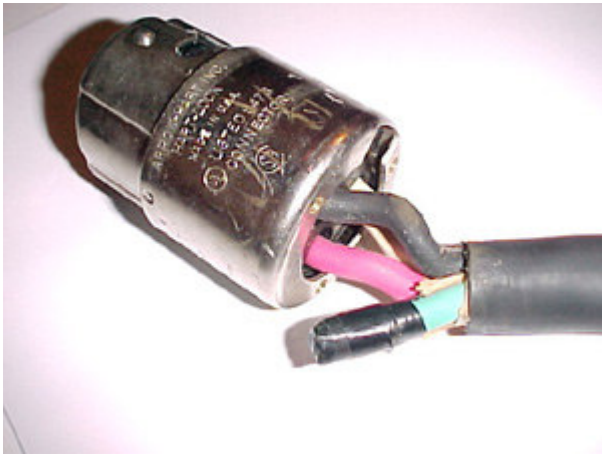
**The boat owner connected a hot conductor to the ground connection.**

We are committed to your safety here at Seven Points Marina but we ask you to be committed to your own safety and those around you. Never alter the manufacturers electrical configuration on your vessel without consulting a qualified marine electrician. Should you have any concerns, please
