## There are no short cuts to safety!

### Dangerous currents.

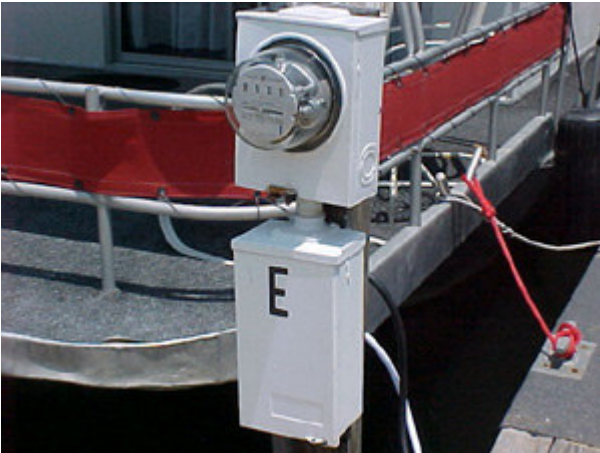
As the investigation into their deaths continued, it became increasingly evident that the women were the victims of a phenomenon that has become known as electric shock drowning.

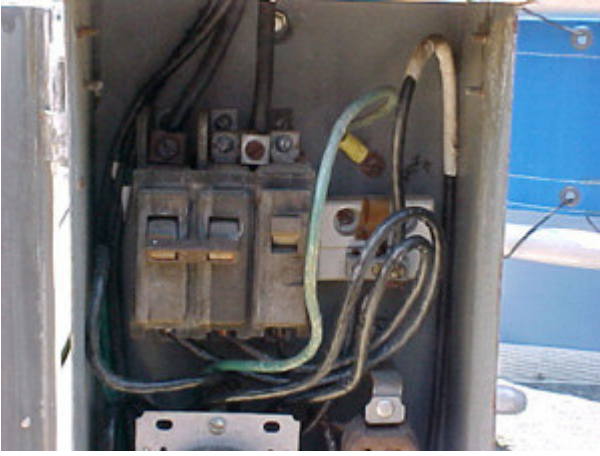
Current takes all paths back to the source, so even with a good ground system there still may be a small voltage rise on the hull as a fault establishes a parallel current path in the water. The boat may become lethal, however, if the ground return is damaged and located in fresh water.

Regardless of the size of the AC fault, the potential may rise to lethal levels as low as 15VAC. Even with a poor ground, a boat in salt water won't develop enough potential to cause a problem for a swimmer, making this an unheard of phenomenon with boats in the ocean.
